Milestone Inspection Report Phase 1

Beaumer Condominium Association, Inc.

**805 Riverpoint Drive, Building C 805
Naples, FL 34102**

Prepared on:
5/24/2024

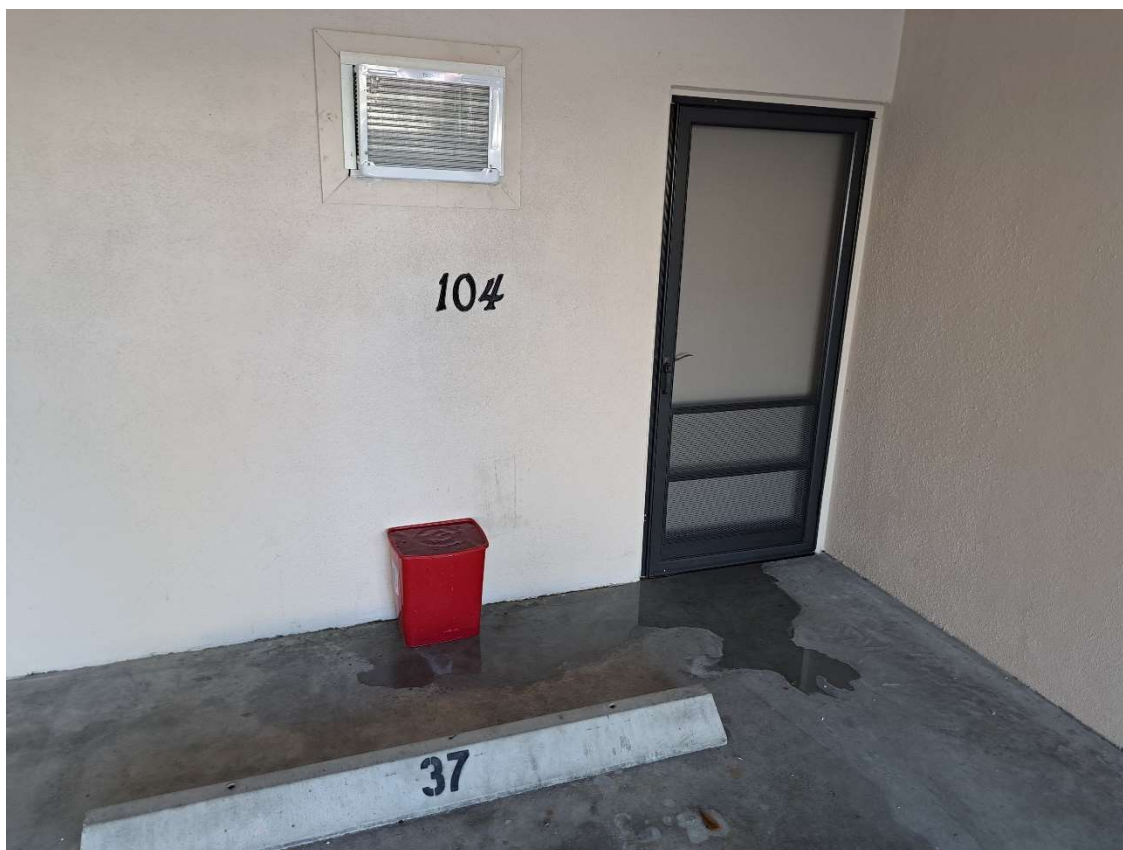
- 2.1.1.1 One air conditioner was draining directly onto the garage floor (Photo 01). Downspouts and air conditioner drains empty too close to the foundation (Photos 02, 03, 04, 05 Typical). Chronic water penetration into the foundation system can accelerate the degradation of the concrete there. This is especially undesirable if the seepage is chronically soaking an underground column or wall footer. See *Carbonation & the Concrete Spalling / Degradation Process* (pg. 2).

Photo 01 Ref: 2.1.1.1 – Air Conditioner Condensate Draining Directly Onto Floor

3.1.1.1 The runoff from the downspouts and air conditioner units should be routed approximately 4 to 5 feet away from the side of the building (especially where footers are located) if possible.

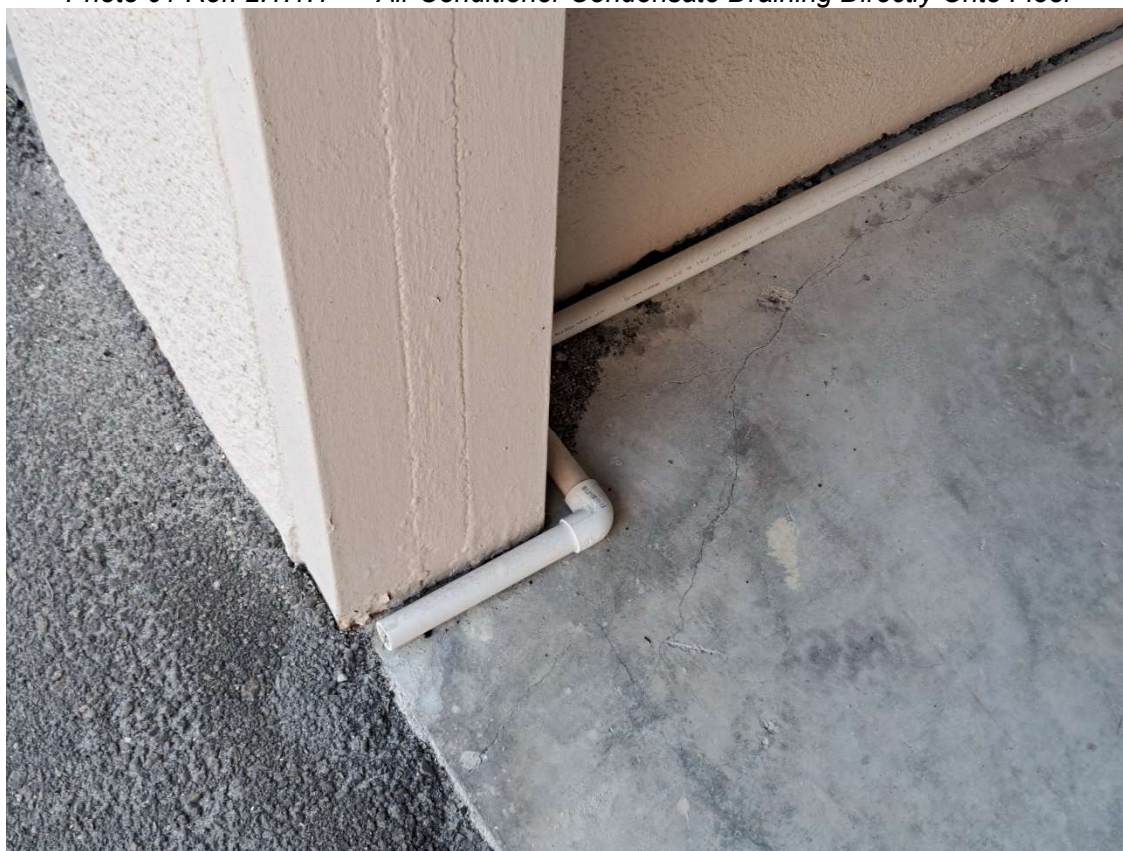
Photo 02 Ref: 2.1.1.1 – Air Conditioner Condensate Draining Next To Foundation

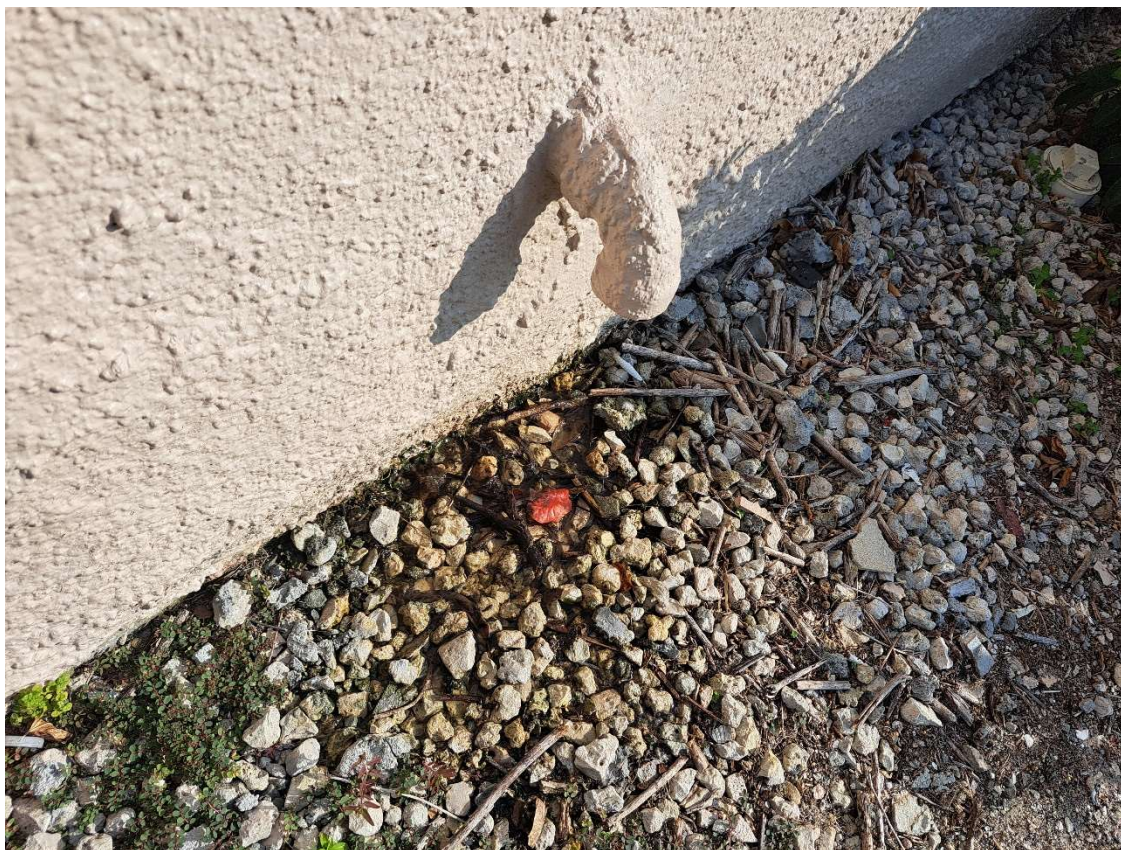
Photo 03 Ref: 2.1.1.1 – Downspouts Draining Next To Foundation

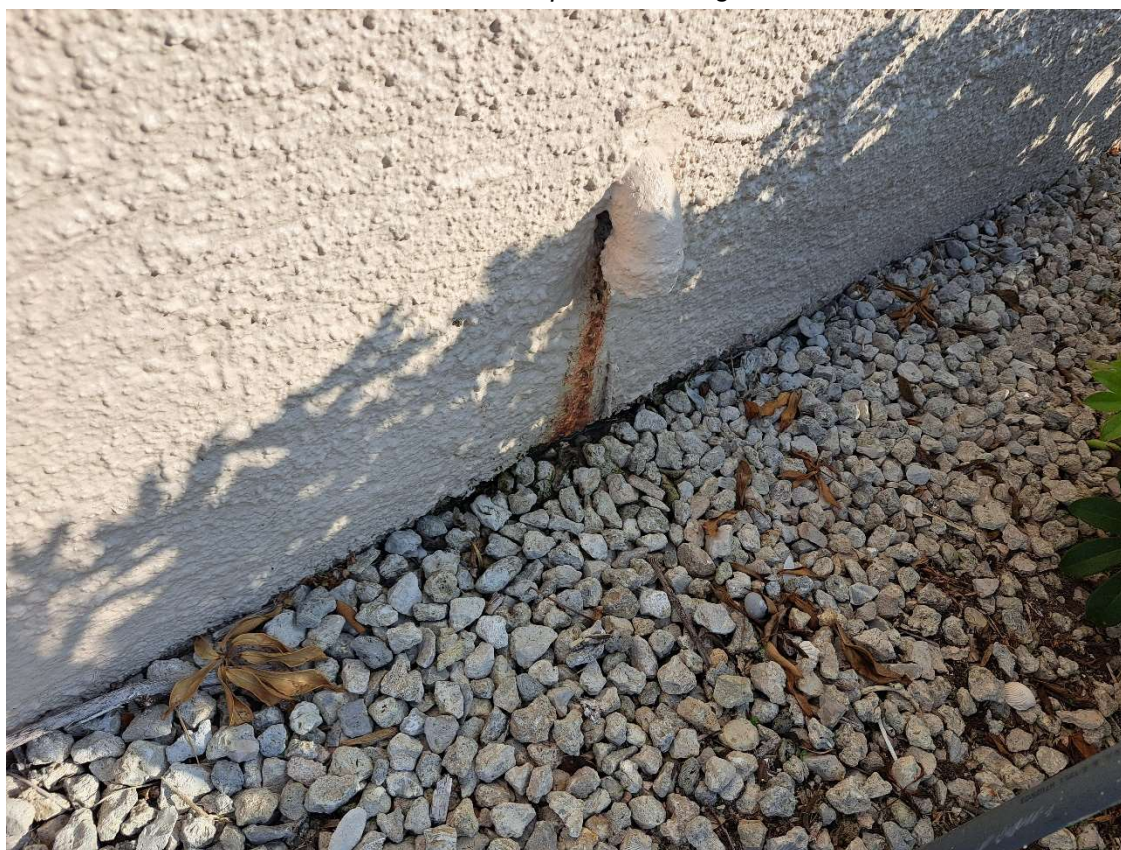
Photo 04 Ref: 2.1.1.1 – Downspouts Draining Next To Foundation

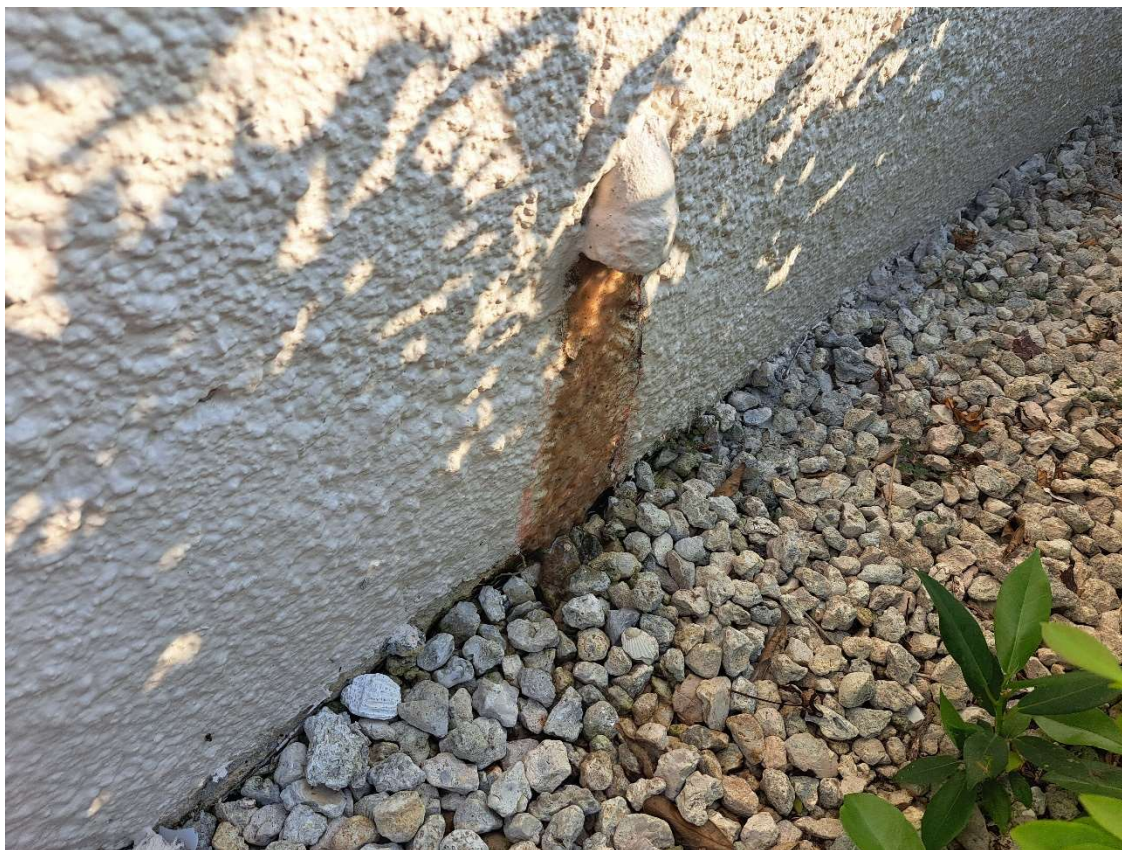
Photo 05 Ref: 2.1.1.1 – Downspouts Draining Next To Foundation

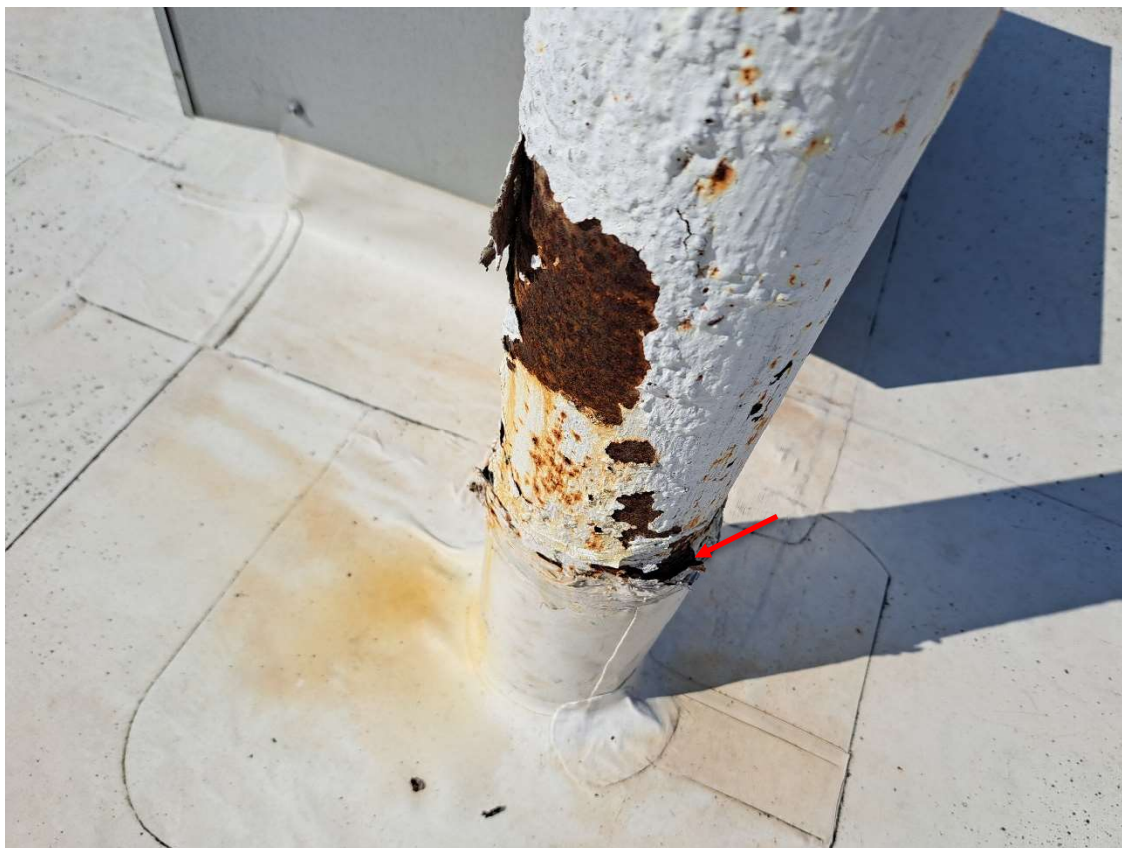
- 2.1.2.1 The upper flashing around the fire hydrant pipe on the roof, is damaged (Photo 06). This will soon allow rain to bypass the roof and dribble down the outside of the pipe and into the building structure. Moisture accelerates the degradation of the concrete. See *Carbonation & the Concrete Spalling / Degradation Process* (pg. 2).

Photo 06 Ref: 2.1.2.1 – Damaged Upper Flashing of the Fire Hydrant Pipe on the Roof

3.1.1.2 The uppermost flashing around the fire hydrant pipe on the roof should be re-done.
