BeauMer Condominium Association, Inc.
Non-SIRS Components
Naples, FL

Report #: 38199-2
Beginning: January 1, 2024
Expires: December 31, 2024

RESERVE STUDY
Update "With-Site-Visit"

September 20, 2023

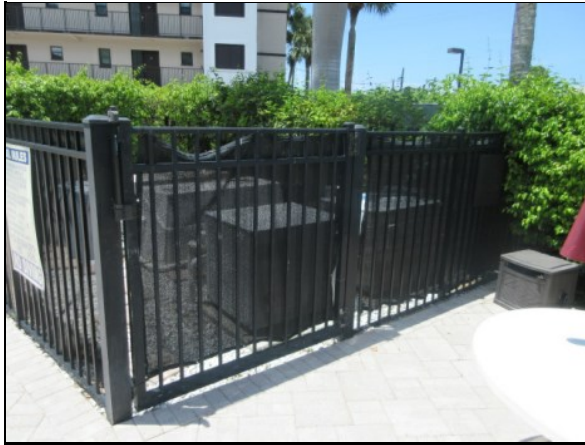
Comp #: 2771 Pool Fencing (Metal) - Replace

Useful Life:
20 years

Remaining Life:
9 years

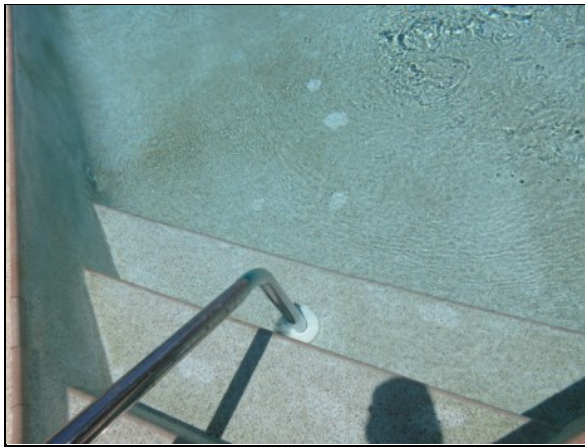
Poor condition: Swimming pools determined to be in poor condition typically exhibit obvious discoloration or staining, and/or chipped, scratched or cracked areas. Pitted, rough texture is usually noticeable in many/most areas at this stage, and delaying resurfacing may result in more accelerated deterioration to the surface and pool structure.

Minor repairs and routine cleaning/maintenance should be considered an Operating expense. Pool resurfacing will restore the aesthetic quality of the pool while protecting the actual concrete shell of the pool from deterioration. This type of project is best suited for slow/offseason to minimize downtime during periods when pool is used heavily. Should be expected at the approximate interval shown below; in some cases, schedule may need to be accelerated due to improper chemical balances or aesthetic preferences of the Client. While drained for resurfacing, any other repairs to lighting, handrails, stairs, ladders, etc. should be conducted as needed.

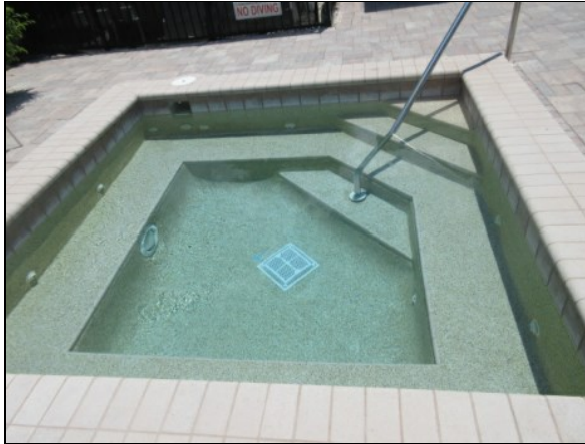
Poor condition: Spas determined to be in poor condition typically exhibit obvious discoloration or staining, and/or chipped, scratched or cracked areas. Pitted, rough texture is usually noticeable in many/most areas at this stage, and delaying resurfacing may result in more accelerated deterioration to the surface and pool structure.

Minor repairs and routine cleaning/maintenance should be considered an Operating expense. Spas sometimes need to be resurfaced more frequently than pools due to higher chance of chemical imbalances. This type of project is best suited for slow/offseason to minimize downtime during periods when spa is used heavily. Whenever possible, both the pool and spa should be done at the same time to achieve better pricing and minimize downtime. While drained for resurfacing, any other repairs to lighting, handrails, stairs, ladders, etc. should be conducted as needed.

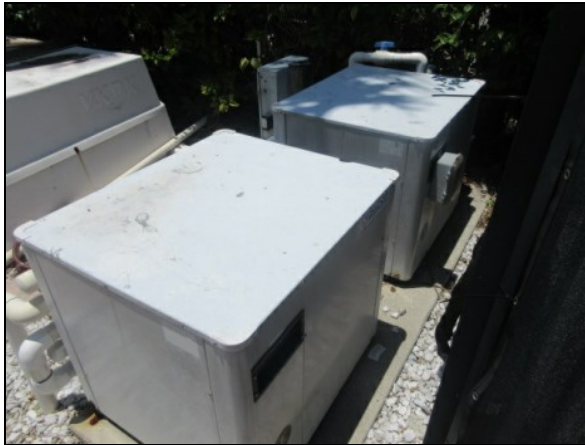
Comp #: 2781 Pool Heaters - Replace

2017: Geothermal heater repairs completed at a cost of \$1,863.29 (per information provided)

Pool vendor should inspect heater regularly to ensure proper function, identify any required repairs, etc. Minimal or no subjective/aesthetic value for pool and spa equipment. Internal components were not analyzed during our site inspection. Useful life is based primarily on normal expectations for service/performance life in this location. Many Clients choose not to heat their pools year-round, which can prolong the life of the heater while reducing energy costs. Unless otherwise noted, remaining useful life expectancy is based primarily on original installation or last replacement/purchase date, our experience with similar systems/components, and assuming normal amount of usage and good preventive maintenance. When replacement models are being evaluated, we recommend considering high efficiency models which may have a higher initial cost but will ultimately be less expensive due to reduced energy usage.

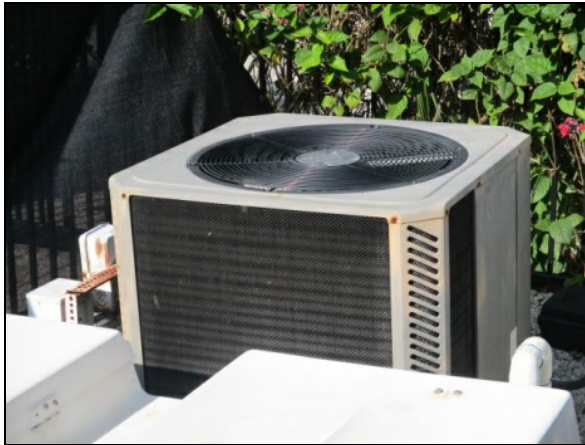
Comp #: 2781 Spa Heater - Replace

2017: Electric heater capacitor repaired at a cost of \$251.15

2021: Replaced at a cost of \$7,425 (per information provided)

Pool vendor should inspect heater regularly to ensure proper function, identify any required repairs, etc. Minimal or no subjective/aesthetic value for pool and spa equipment. Internal components were not analyzed during our site inspection. Useful life is based primarily on normal expectations for service/performance life in this location. Many Clients choose not to heat their pools year-round, which can prolong the life of the heater while reducing energy costs. Unless otherwise noted, remaining useful life expectancy is based primarily on original installation or last replacement/purchase date, our experience with similar systems/components, and assuming normal amount of usage and good preventive maintenance. When replacement models are being evaluated, we recommend considering high efficiency models which may have a higher initial cost but will ultimately be less expensive due to reduced energy usage.

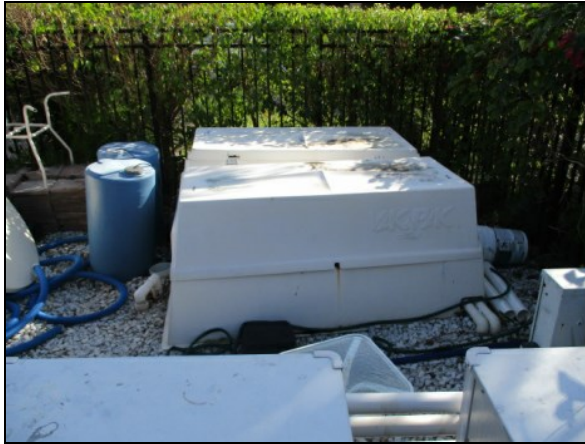
Comp #: 2787 Pool Equipment - Maintain/Replace**Quantity: Lump Sum Allowance**

2017: 1-HP pump motor replaced at a cost of \$425

GFCI outlet replaced at a cost of \$181.94

2018: Repairs (undisclosed scope of work) completed at a total cost of \$9,231.29
