**BeauMer Condominium Association, Inc.**  
**SIRS Components**  
***Naples, FL***

Report #: 38199-2  
Beginning: January 1, 2024  
Expires: December 31, 2024

**RESERVE STUDY**  
**Update "With-Site-Visit"**

September 20, 2023

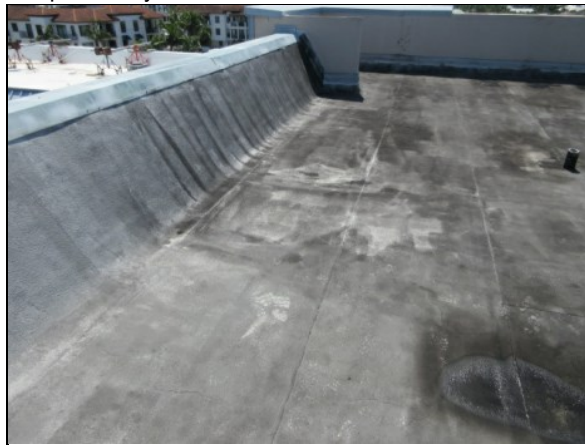
Useful Life:  
20 years

Remaining Life:  
19 years

Best Case: \$ 89,800

Worst Case: \$ 109,700

| # Component | Useful Life<br>(yrs) | Rem.<br>Useful Life<br>(yrs) | Current<br>Average<br>Cost |
|---|---|---|---|
| 2377 Modified Bitumen Roofing - Replace | 20 | 19 | \$99,750 |

| # | Component | Current Cost Estimate | X | Effective Age | / | Useful Life | = | Fully Funded Balance |
|---|---|---|---|---|---|---|---|---|
| 2377 | Modified Bitumen Roofing - Replace | \$99,750 | X | 1 | / | 20 | = | \$4,988 |

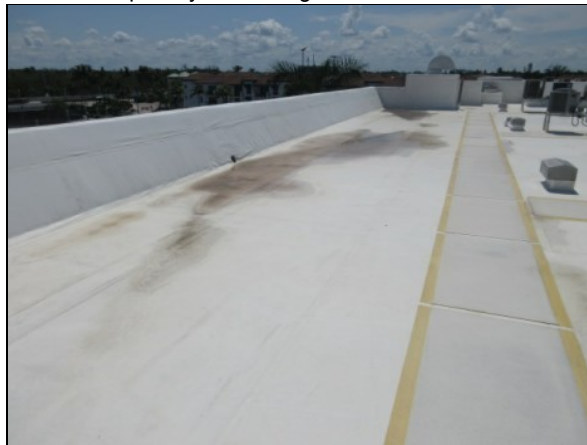
Useful Life:  
20 years

Remaining Life:  
15 years

Best Case: \$ 410,400

Worst Case: \$ 501,600

| # Component | Useful Life<br>(yrs) | Rem.<br>Useful Life<br>(yrs) | Current<br>Average<br>Cost |
|---|---|---|---|
| 2378 Single Ply Roofing - Replace | 20 | 15 | \$456,000 |

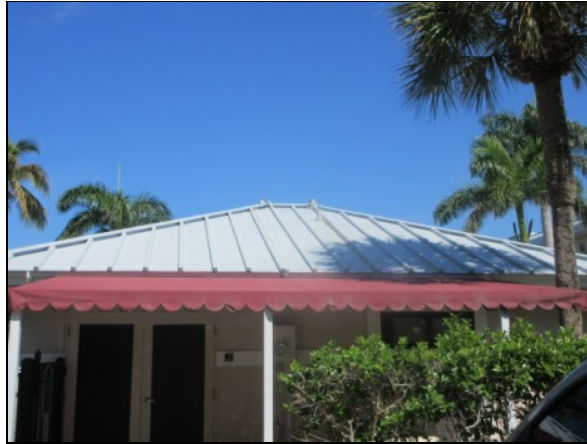
Useful Life:  
30 years

Remaining Life:  
20 years

Best Case: \$ 15,300

Worst Case: \$ 18,700

| # Component | Useful Life<br>(yrs) | Rem.<br>Useful Life<br>(yrs) | Current<br>Average<br>Cost |
|---|---|---|---|
| 2384 Metal Roofing - Replace | 30 | 20 | \$17,000 |

| # | Component | Useful Life (yrs) | Current Cost Estimate | Deterioration Cost/Yr | Deterioration Significance |
|---|---|---|---|---|---|
| 2384 | Metal Roofing - Replace | 30 | \$17,000 | \$567 | 0.33 % |

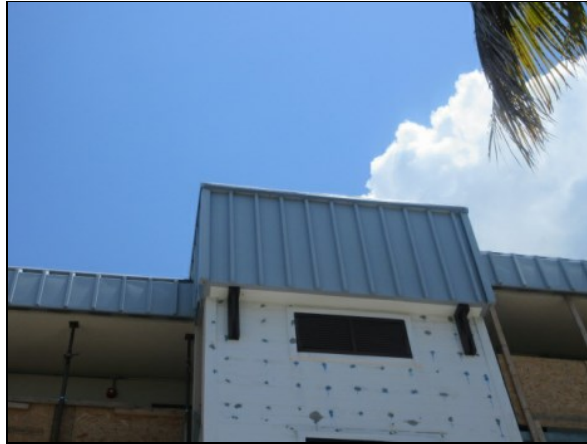
Useful Life:  
30 years

Remaining Life:  
20 years

Best Case: \$ 236,500

Worst Case: \$ 289,100

| # Component | Useful Life<br>(yrs) | Rem.<br>Useful Life<br>(yrs) | Current<br>Average<br>Cost |
|---|---|---|---|
| 2387 Mansard Roofing (2014) - Replace | 30 | 20 | \$262,800 |

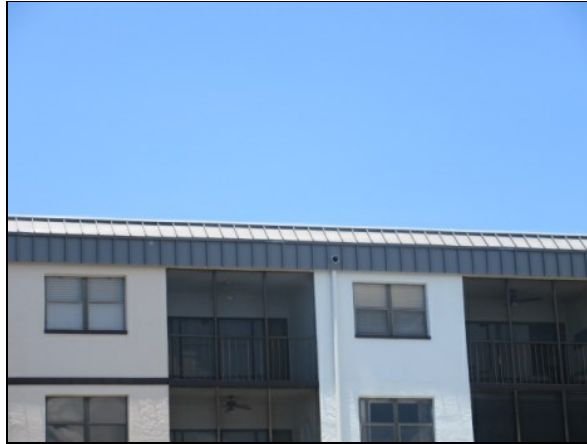
Useful Life:  
30 years

Remaining Life:  
25 years

Best Case: \$ 65,500

Worst Case: \$ 80,100

| # Component | Useful Life<br>(yrs) | Rem.<br>Useful Life<br>(yrs) | Current<br>Average<br>Cost |
|---|---|---|---|
| 2387 Mansard Roofing (2019) - Replace | 30 | 25 | \$72,800 |

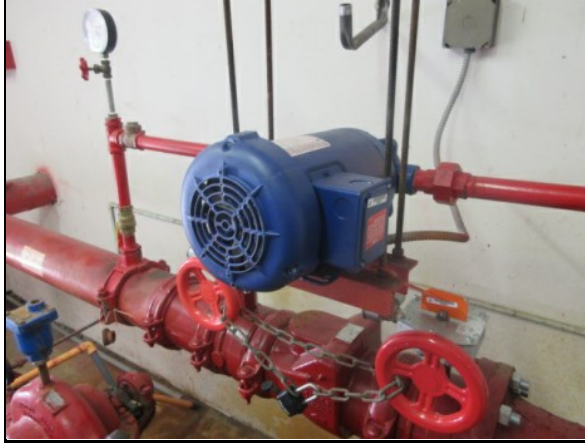
Useful Life:  
10 years

Remaining Life:  
5 years

Best Case: \$ 6,000

Worst Case: \$ 8,000

| # Component | Useful Life<br>(yrs) | Rem.<br>Useful Life<br>(yrs) | Current<br>Average<br>Cost |
|---|---|---|---|
| 2561 Fire Sprinkler Jockey Pump -Replace | 10 | 5 | \$7,000 |

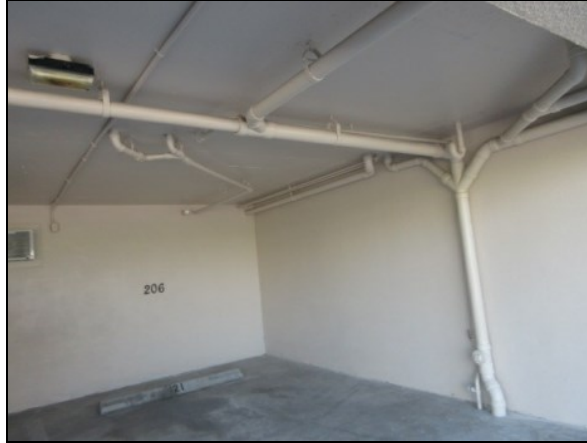
Useful Life:  
10 years

Remaining Life:  
0 years

Best Case: \$ 92,000

Worst Case: \$ 172,000

| # Component | Useful Life<br>(yrs) | Rem.<br>Useful Life<br>(yrs) | Current<br>Average<br>Cost |
|---|---|---|---|
| 2579 Plumbing Systems - Repair/Replace | 10 | 0 | \$132,000 |

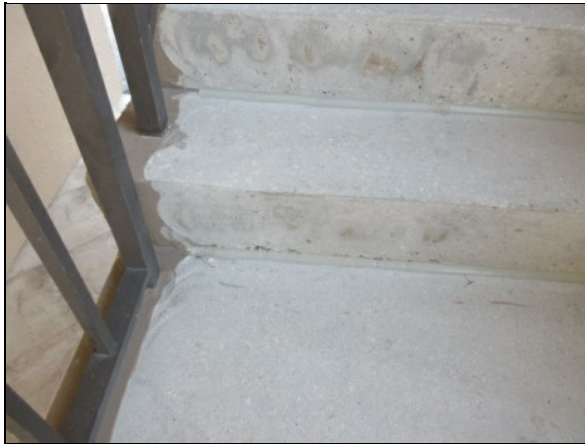
Useful Life:  
4 years

Remaining Life:  
3 years

Best Case: \$ 32,400

Worst Case: \$ 39,600

| # Component | Useful Life<br>(yrs) | Rem.<br>Useful Life<br>(yrs) | Current<br>Average<br>Cost |
|---|---|---|---|
| 2315 Walkway Decks - Repair/Re-coat | 4 | 3 | \$36,000 |

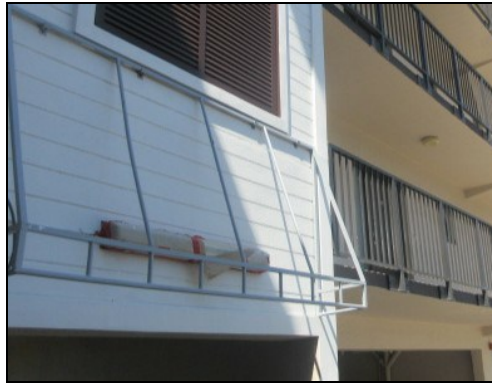
Useful Life:  
30 years

Remaining Life:  
19 years

Best Case: \$ 45,000

Worst Case: \$ 55,000

| # Component | Useful Life<br>(yrs) | Rem.<br>Useful Life<br>(yrs) | Current<br>Average<br>Cost |
|---|---|---|---|
| 2308 Awnings (Frames) - Replace | 30 | 19 | \$50,000 |

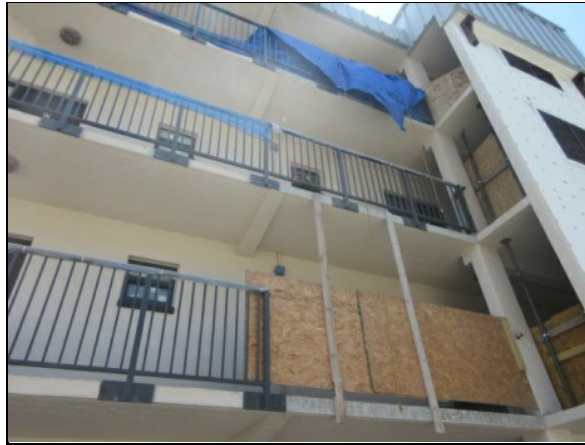
Remaining Life:

24 years

Best Case: \$ 441,000

Worst Case: \$ 539,000

| # Component | Useful Life<br>(yrs) | Rem.<br>Useful Life<br>(yrs) | Current<br>Average<br>Cost |
|---|---|---|---|
| 2326 Stairwell/Walkway Railings -Replace | 25 | 24 | \$490,000 |

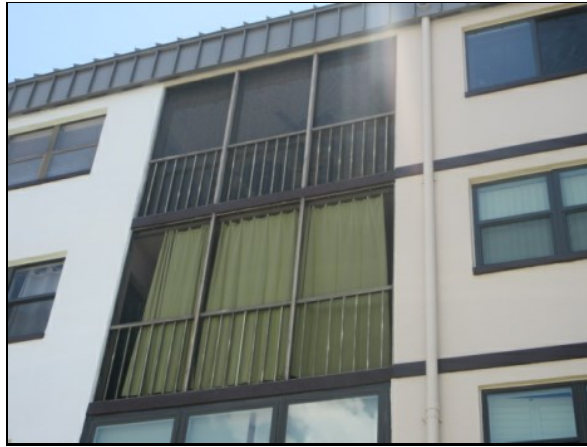
Useful Life:  
30 years

Remaining Life:  
0 years

Best Case: \$ 93,200

Worst Case: \$ 114,000

| # Component | Useful Life<br>(yrs) | Rem.<br>Useful Life<br>(yrs) | Current<br>Average<br>Cost |
|---|---|---|---|
| 2328 Screen Enclosures - Replace | 30 | 0 | \$103,600 |

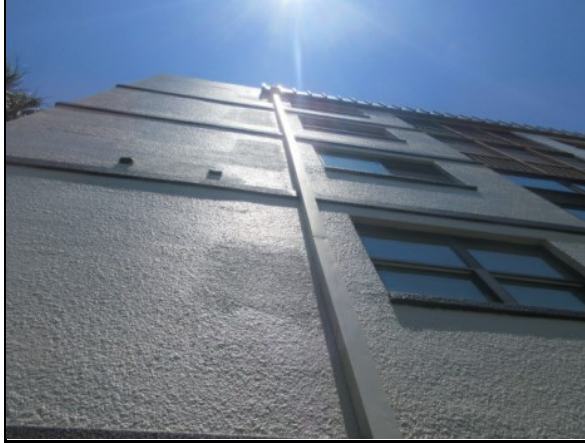
Useful Life:  
20 years

Remaining Life:  
15 years

Best Case: \$ 10,200

Worst Case: \$ 12,500

| # Component | Useful Life<br>(yrs) | Rem.<br>Useful Life<br>(yrs) | Current<br>Average<br>Cost |
|---|---|---|---|
| 2389 Gutters/Downspouts - Replace | 20 | 15 | \$11,350 |

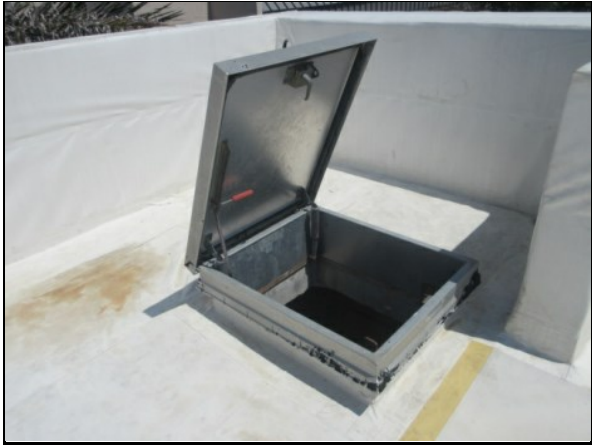
Useful Life:  
20 years

Remaining Life:  
15 years

Best Case: \$ 12,000

Worst Case: \$ 16,000

| # Component | Useful Life<br>(yrs) | Rem.<br>Useful Life<br>(yrs) | Current<br>Average<br>Cost |
|---|---|---|---|
| 2392 Roof Access Hatches - Replace | 20 | 15 | \$14,000 |

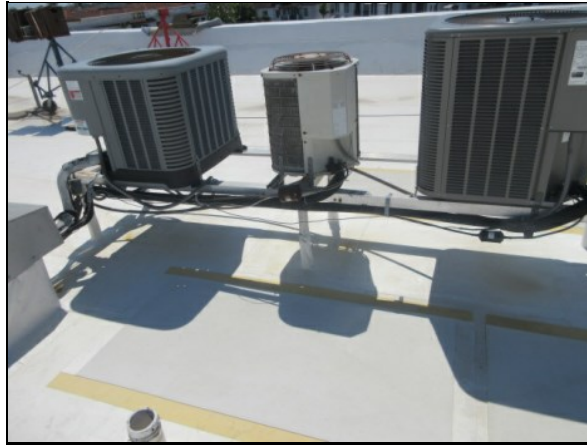
Useful Life:  
30 years

Remaining Life:  
15 years

Best Case: \$ 120,200

Worst Case: \$ 146,900

| # Component | Useful Life<br>(yrs) | Rem.<br>Useful Life<br>(yrs) | Current<br>Average<br>Cost |
|---|---|---|---|
| 2394 HVAC Stands - Replace | 30 | 15 | \$133,550 |
